Data Centre at Imperial Park, Duffryn, Newport

Arboricultural Impact Assessment

Next Generation Data

October 2020

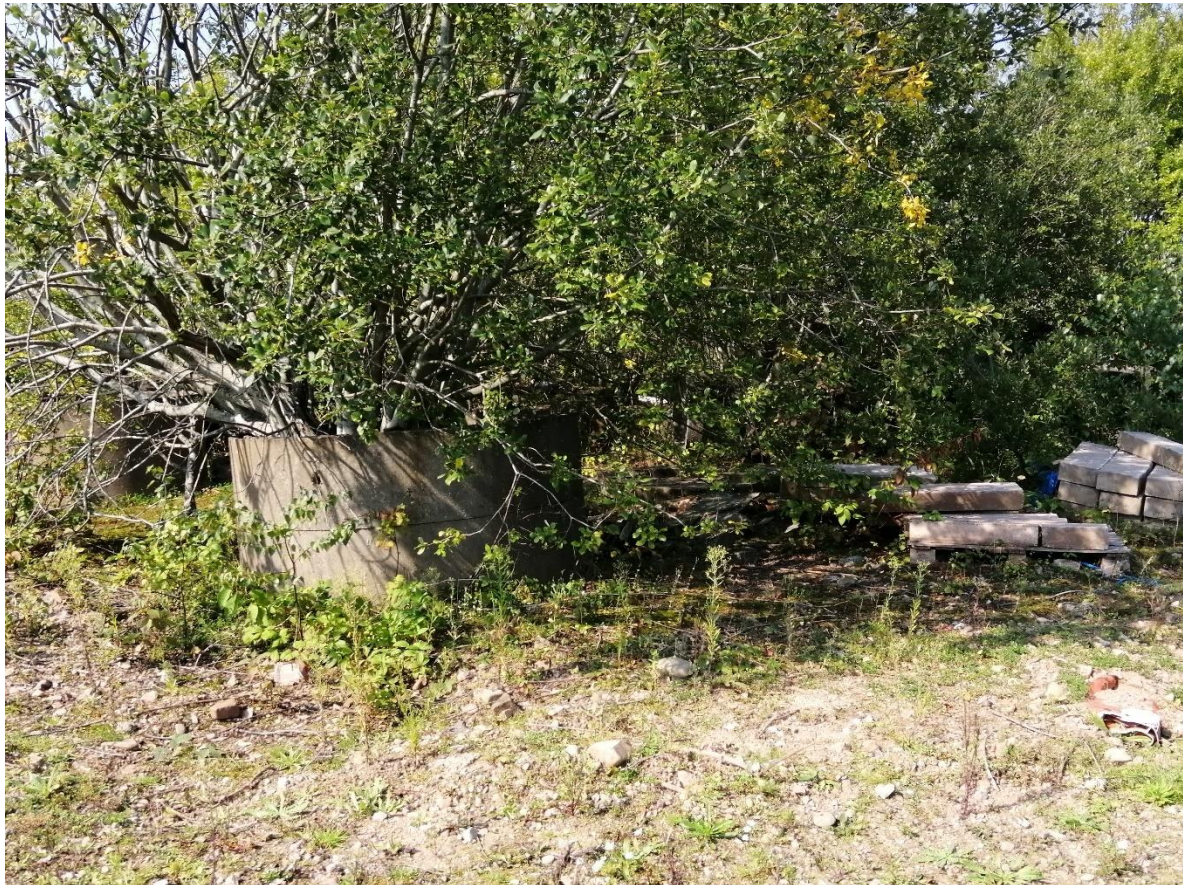
Elsewhere vegetation is growing around and through redundant construction materials strewn around the site, as shown at Figure 2. Although many of the young trees are showing structural defects associated with a lack of formative management, such as co-dominant basal forks, most of the self-set vegetation in groups G001-5 is in good physiological condition.

Figure 2: a goat willow grows inside concrete tubing
